**City of Waukesha, Wisconsin**

**Phase II Final Report  
Sanitary Sewer System Master Plan**

**City of Waukesha**  
September 2011

**Donohue & Associates, Inc.**

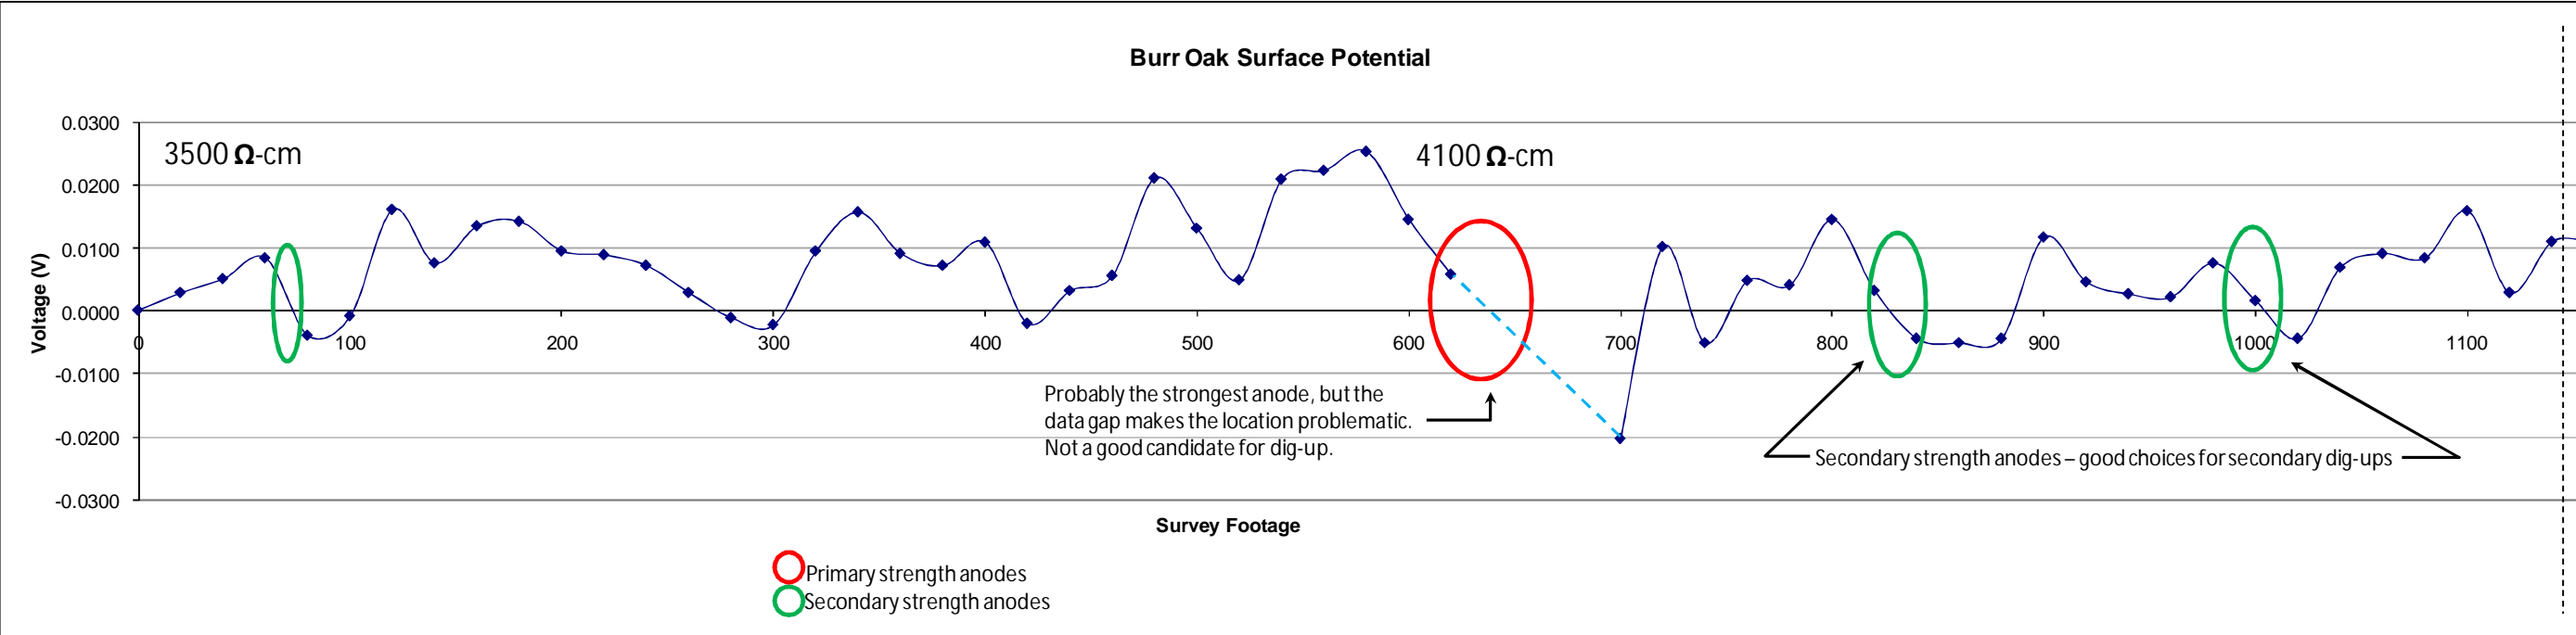
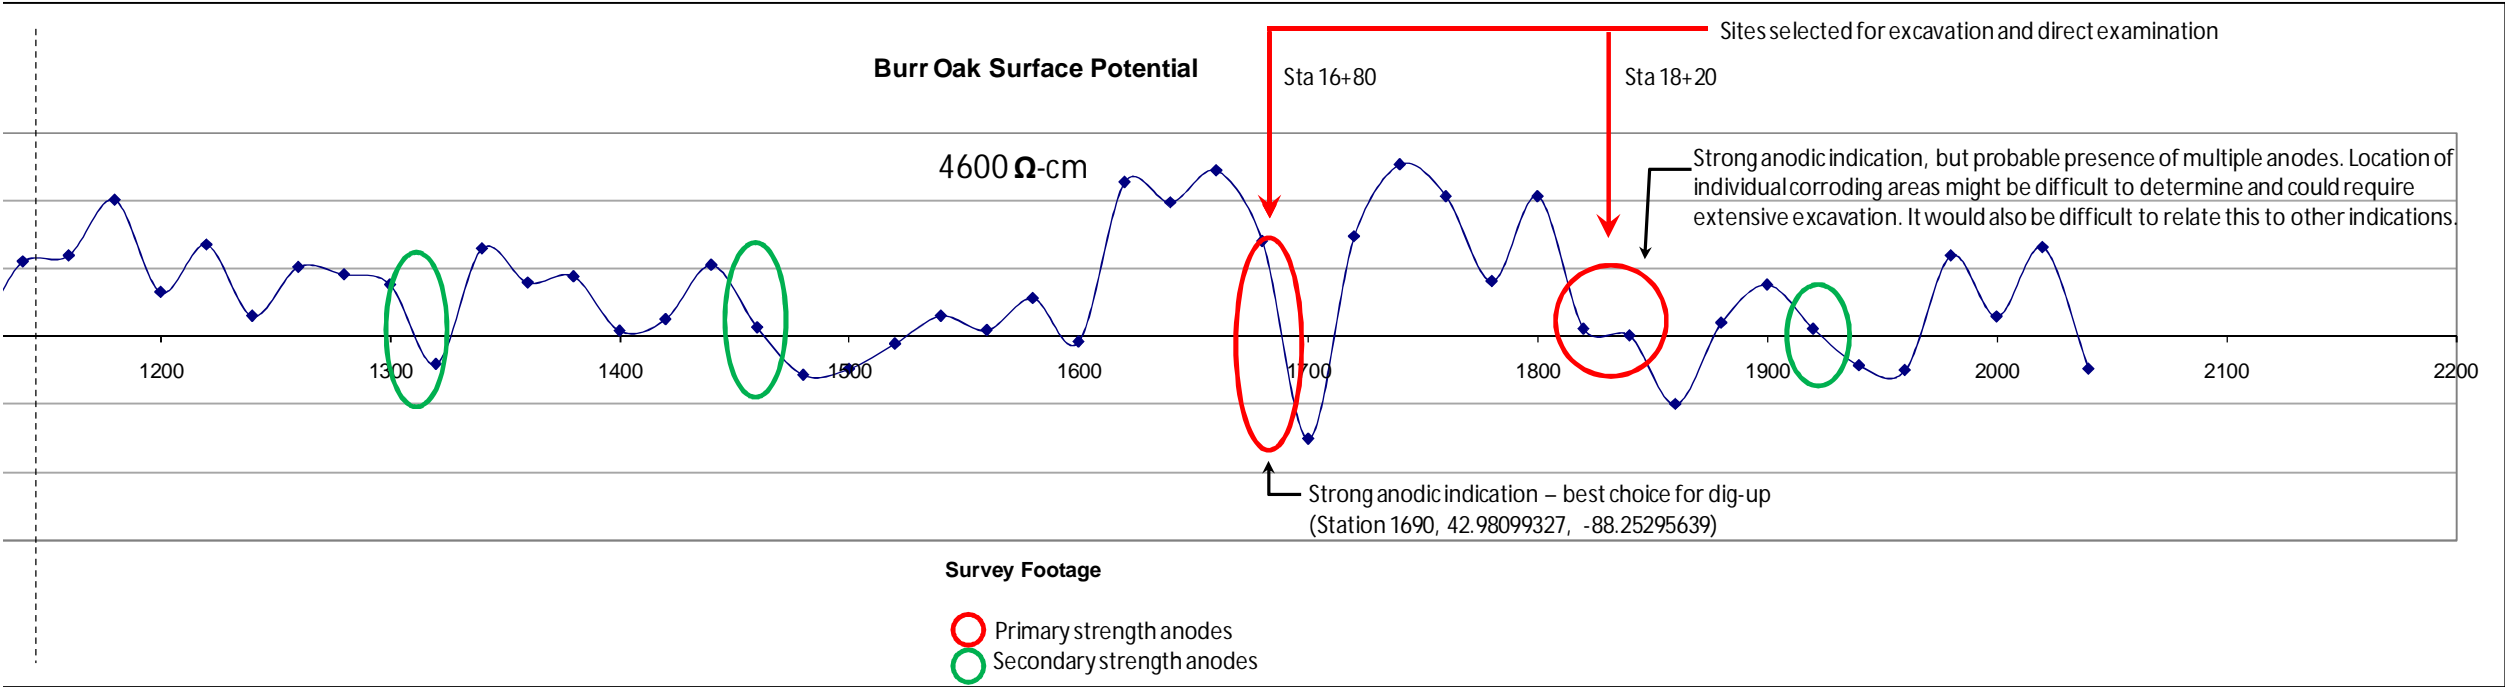
Figure 4 - Burr Oak Surface Potential

The Burr Oak force main was tested from Station 0+00 to Station 20+40, utilizing the Two-Cell Potential Profile technique. Soil resistivity was measured at three locations (Stations 0+00, 6+80 & 15+80). These results are illustrated in Figure 4. Soil resistance ranged from 3500  $\Omega$ -cm to 4600  $\Omega$ -cm; these values are generally considered moderately corrosive. Two-cell potential measurements ranged from +0.0254V to -0.0202V. There are thirteen identifiable anode/cathode pairs in the measurements. Of these anodic locations, nine were isolated as potentially useful for direct examination. Three of these sites were

noted as primary sites (circled in red), those with the largest potential differential, clearest indication of an anodic location, and highest probability of significant corrosion. The other six sites were identified as secondary sites (circled in green), sites of lesser intensity, less clearly anodic locations, and probably experiencing lesser corrosion, but potentially useful for comparison.

Based upon field conditions, two sites were selected for excavation and direct examination. These sites, located at stations 16+80 and 18+20 are indicated on Figure 4 by vertical red arrows. The soil found at pipe depth appeared to be approximately equal parts sand, gravel and clay, typical of the migration of native clay soil into select granular backfill over time. The soil near the pipeline was moist, and the measured soil resistivity far lower (600  $\Omega$ -cm & 800  $\Omega$ -cm) than that measured at grade. This would suggest that corrosion of the pipeline would likely be more severe than would have been suspected from the resistivity measured at grade. The force main surface was found to be covered with a black scale, which may have some protective value. Beneath the scale some scattered pitting was found, with diameters up to ½" and depths to 50 mils. This level of corrosion on a pipeline approximately forty-three years old would be considered minor and does not compromise pipeline integrity.

Each of the thirteen anodic indications was evaluated to determine the apparent relative size of the anode. The potential difference between the measured electro-positive peak prior to the potential reversal and the electro-negative valley following the reversal, and the distance between these points was used to calculate the triangular area beneath this portion of the Two-cell Potential Survey curve. Each of these apparent anode sizes was then compared to the apparent anode sizes at the two directly examined sites, and a relative estimated maximum depth of pitting was calculated. Given an installation date of 1967 and original pipe wall thickness of 0.380", these were converted to an estimated average annual pitting rate and estimated minimum remaining wall thickness. These are illustrated in Figure 5. The measured maximum pit depth of 0.05" at both direct examination sites translates to an average pitting rate of 1.2 mils/yr. Based upon the apparent relative anode sizes, the worst corrosion is occurring at Station 6+35 (Figure 5) adjacent to Cottonwood Drive (Figure 6). Locations adjacent to road crossings commonly have higher corrosion rates. The estimated maximum depth of penetration at this location would be 160 mils, translating to an average pitting rate of 3.7 mils/yr and a minimum remaining wall thickness of just less than 58 percent. This appears to be an area that should be re-tested every 5-10 years. Should conditions remain the same, and barring structural failure due to pipe wall thinning, the estimated pitting rate would produce a pipe wall penetration in approximately sixty years.

At each of the direct examination sites, a galvanic anode was connected to the exposed pipeline. This should protect the individual pipe stick at this location and preserve it from further corrosion for at least the next twenty years. Unfortunately, since this force main is electrically discontinuous, the anode will have minimal, if any, effect on the remainder of the pipeline.

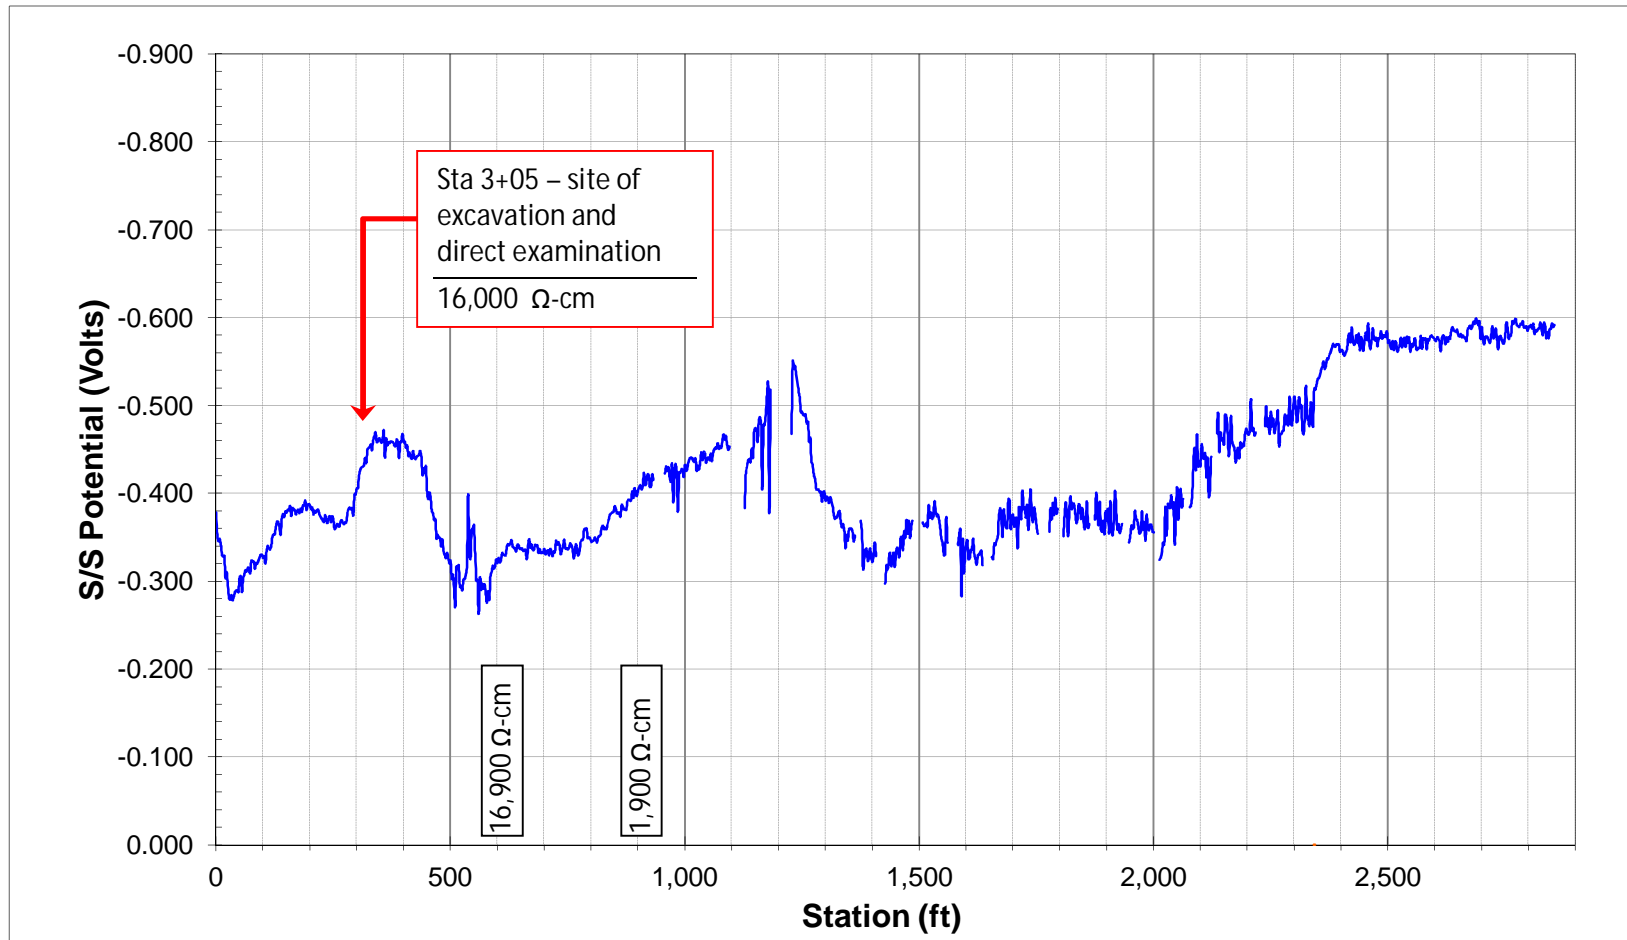
Figure 7 – Greenmeadow Force Main CIS Profile

The Greenmeadow force main was tested between stations 0+00 and 28+55. This force main was electrically continuous; therefore, a CIS was performed (results in Figure 7). Soil resistance was measured at two locations, Station 6+15 and Station 9+03 with readings of 16,900  $\Omega$ -cm and 1900  $\Omega$ -cm, respectively. At the higher soil resistivity, little or no corrosion would be expected. This is consistent with its proximity to the most cathodic measured pipe-to-soil (P/S) potential of -0.2628V at Station 5+60. Conversely, a soil resistivity of 1900  $\Omega$ -cm would be considered corrosive, particularly if there is a rapid transition from a much higher soil resistivity (as in this case). This is consistent with the location of this soil resistivity midway between the high resistivity and the second most anodic (electro-negative) P/S potential measurement. Measured P/S ranged from a most cathodic -0.2628V at Station 5+60 to a most anodic value of -0.599V at Station 26+88. This entire range of P/S is within the normally expected range for buried iron. The CIS profile (Figure 7) indicates three locations that are significantly more anodic than the remainder of the force main; one centered on Station 3+57, one centered on Station 12+30, and the most anodic location at Station 26+88. The anodic indication at Station 26+88 was not recommended for direct examination because of its proximity to the end of the line and the possibility that the P/S measurements there might be influenced by connected structures. Based upon field conditions, an excavation and direct examination was conducted at Station 3+05.

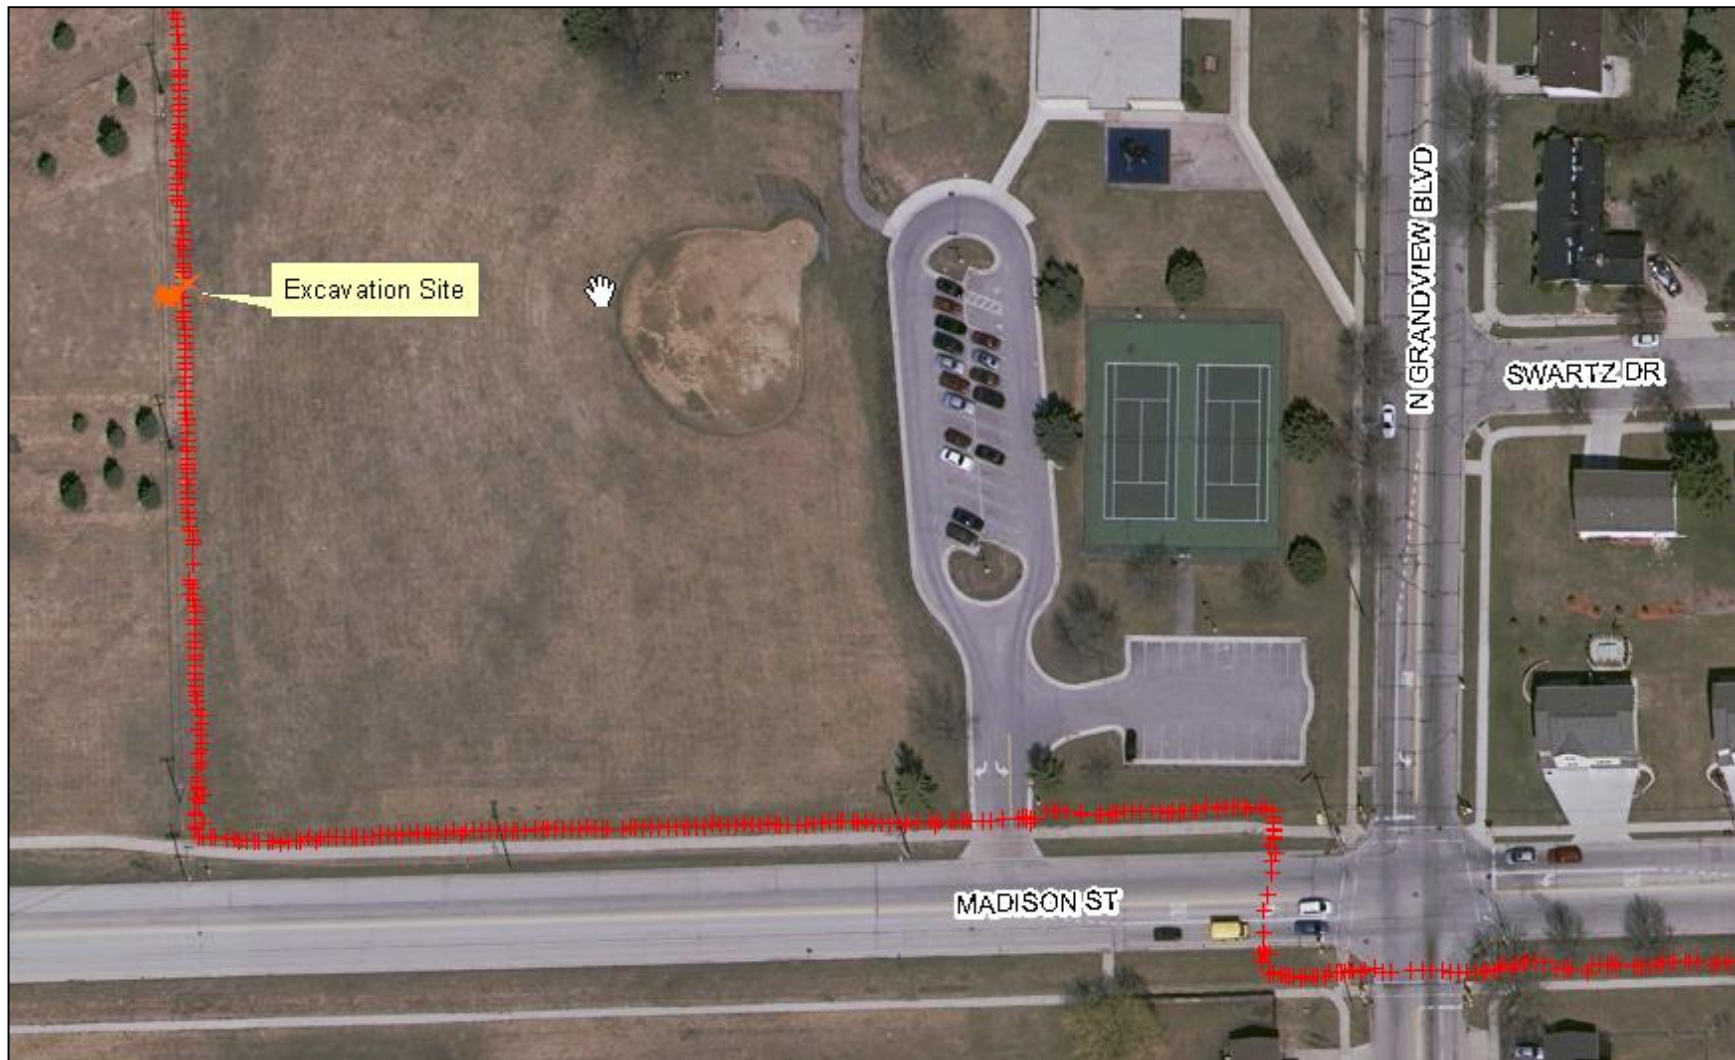
Figure 8 – Greenmeadow Excavation Site

The excavation at Station 3+05 found pipeline backfill composed primarily of sand. The excavation was dry and there was no evidence of migration of native soil into the backfill. This suggests that there is little groundwater flow through this area. Soil resistivity measured in the trench was high (16000  $\Omega$ -cm), similar to that measured at grade. Condition of the exposed pipe was nearly pristine, with no evidence of corrosion. This is consistent with the high soil resistivity and dry conditions.

No corrosion was found during the direct examination at Station 3+05 making it impossible to extrapolate conditions to the remainder of the pipeline. One possibility is that while this section of the force main has a high natural potential for corrosion, environmental conditions inhibit the corrosion reaction. Under this scenario, only the two areas (Station 12+30 & Station 26+88) with more anodic P/S potentials are likely to be corroding, although we cannot estimate at what rate; and the remainder of the pipeline should be essentially corrosion free. Alternatively, the corrosion causing this anodic indication may be located somewhat up-station from the area directly examined and the excavation may simply have missed it. If this is the case we can make no statement regarding the level of corrosion on the force main.

Because the excavated pipe was in such excellent condition and the coating was intact, no anode was installed at this location. The twenty-seven year history with no corrosion at Station 3+05 suggests that no corrosion failures are likely at this location in the foreseeable future, however this cannot be assumed for the remainder of the force main. This leaves two alternatives. First, a more detailed study could be performed to assess the condition of the remainder of the pipeline. Alternatively, since this force main is electrically continuous, it could easily be placed under cathodic protection preventing any further corrosion. The latter is probably the most cost-effective option.

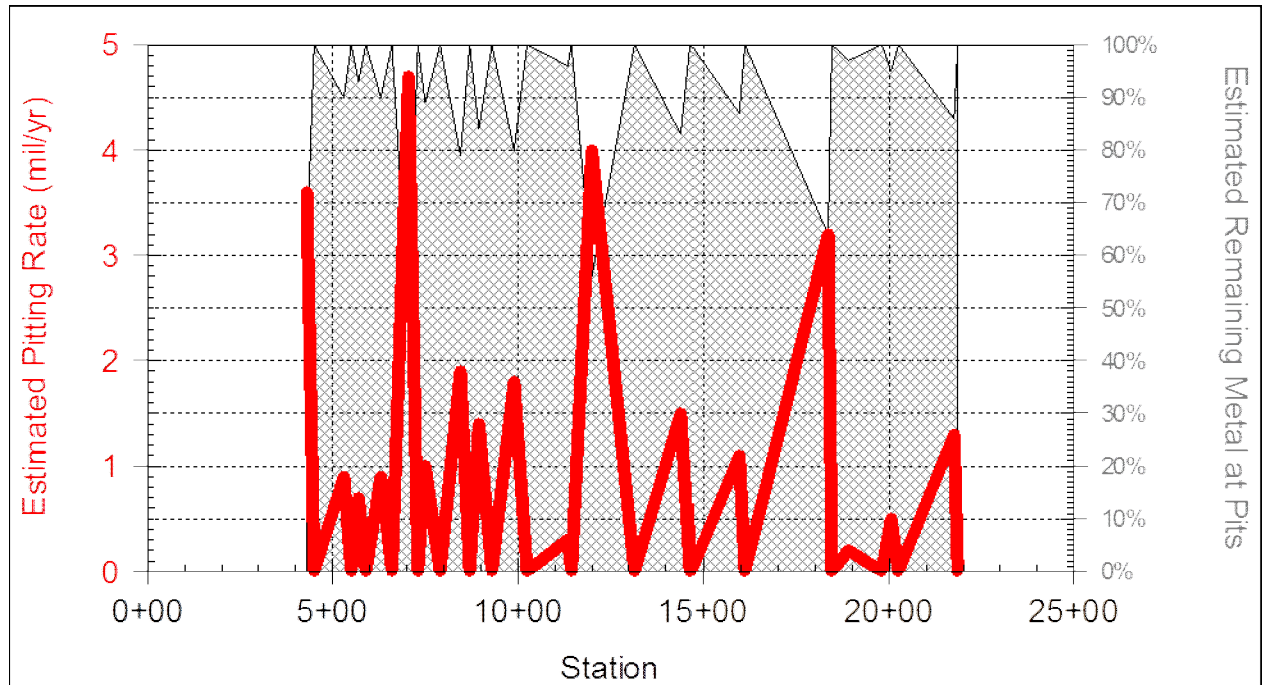
Figure 10 – Heyer Drive Force Main Estimated Condition

All seventeen anodic indications were evaluated and compared to the directly examined site (Figure 10). The extrapolation calculations suggest three locations of possible concern with potential pitting as much as fifty percent of the pipe wall thickness. Again it must be remembered that these are extrapolations from a very limited data set and should not be viewed in the same light as actual measured values. The locations of concern are at Stations 7+05, 12+00 and 18+35 (Figure 11) where thinning of the pipe wall is likely at its maximum. These areas are estimated to have pitting rates of 3 to 5 mils/yr. Consistent with the estimated maximum depth of penetration and pipe age, the estimated maximum pitting should be expected to take another forty years for pipe penetration to occur. Leakage would be expected sooner than that as internal pressure exceeds the strength of the remaining material

An anode was installed on the exposed pipeline to protect this pipe stick from corrosion. Waukesha might want to closely monitor the areas identified as having a probability of significant corrosion pitting by re-testing every 5-10 years. Since the observed corrosion has consisted of scattered pitting, the probable mode of failure, should it occur, would likely be a leak of some size rather than a sudden catastrophic failure. If opportunities to expose the force main in these areas present themselves, it should be examined for the presence of corrosion and the condition analysis adjusted to reflect any new measurements.

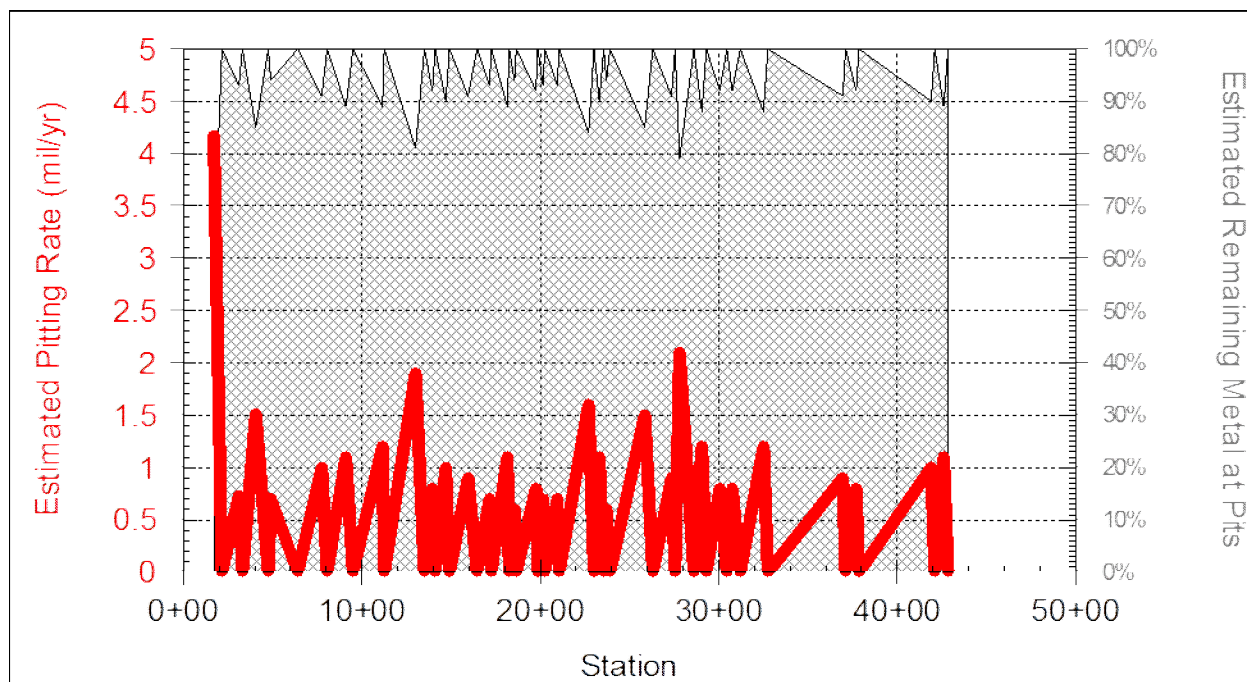
Figure 13 – Pebble Valley Force Main Estimated Condition

Figure 13 graphically depicts an evaluation of the thirty-one anodic indications. Although there were numerous indications on this force main, they do not appear to be severe. In only one case does the estimated pitting rate exceed 2 mils/yr., and at only five locations does the estimated maximum pitting depth exceed ten percent of the pipe wall thickness. The evaluation does not indicate any areas of concern on this force main.

Galvanic anodes were installed at each excavation location. These should provide local protection from corrosion. Of particular concern is the situation at Station 13+00. This emphasizes the importance of preventing contact between crossing pipes during construction.

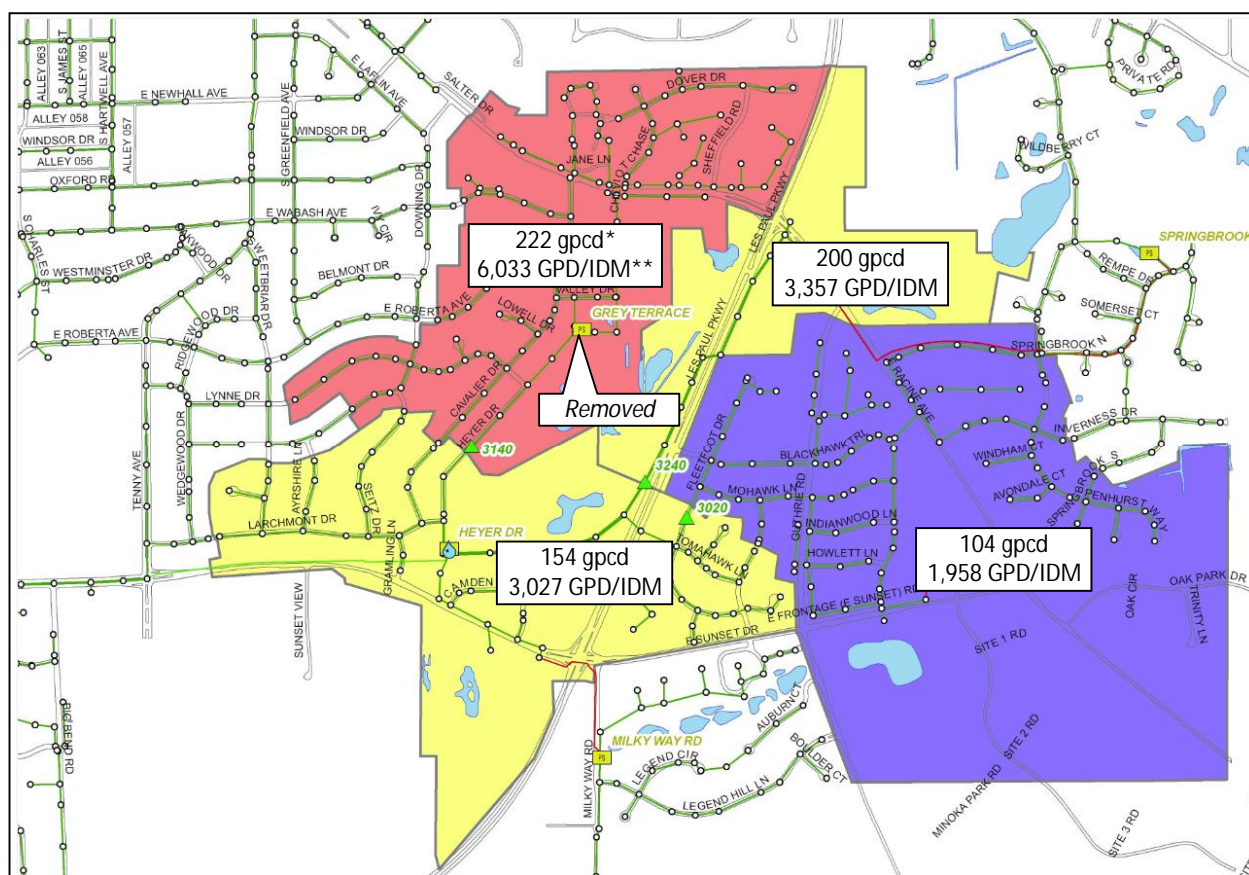
Figure 14 – Heyer Drive Infiltration

The results of this analysis are shown in Figure 14, which indicates that the majority of the infiltration is originating in the area north of the pump station, and upstream of manhole 3140. This is consistent with observations made by City personnel, who have observed high clear water flow rates in the vicinity of where the Grey Terrace pump station had been.

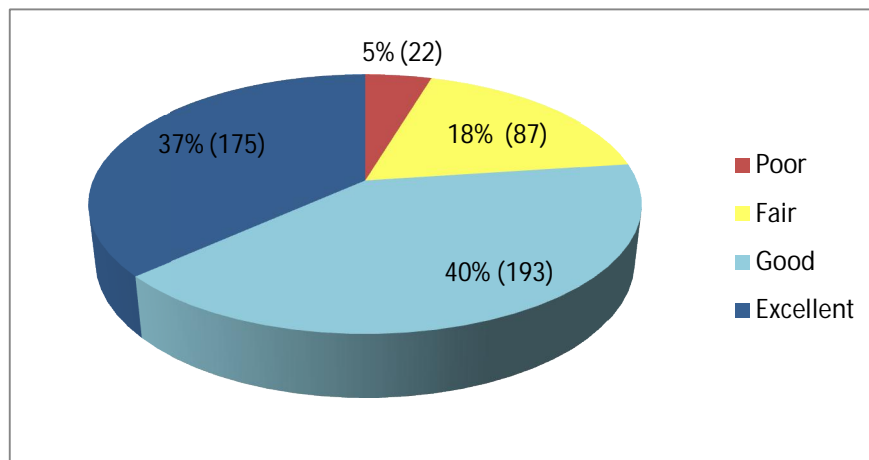
Figure 16 – Condition of Inspected Manholes

Donohue used this database to develop a rating system, categorizing the manholes as being in excellent, good, fair, or poor condition. Of the 477 manholes inspected, 368 (77%) were found to be in good to excellent condition, as shown in Figure 16. The locations of these manholes are shown in Figure 17. These ratings are based on a generic rating algorithm; therefore, Donohue evaluated the specific defects of each manhole in order to develop specific rehabilitation recommendations.
